#1016 - Stainless Steel Electropolishing for Micro Finish Improvement

Aerospace - Manufacturer of piston assemblies for the aircraft industry

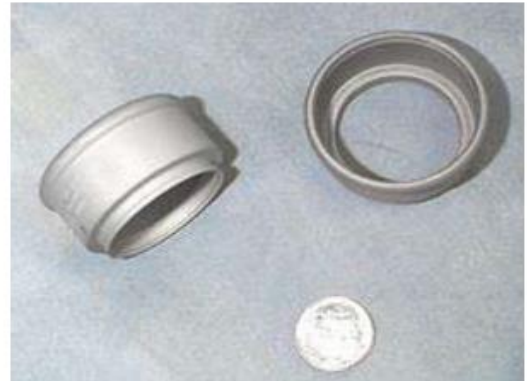
This part is used as a flex coupling, and has seal rings inserted inside. The part is copper-plated to act as a mask prior to Malcomizing/heat treating. After Malcomizing, the "sleeve" is stripped of the copper plating by reverse electrolysis, leaving behind a notably rough surface finish.

Able Electropolishing treated the entire part with electropolishing, with the specification to remove a controlled amount of material in order to achieve the required surface finish. After electropolishing, the "sleeve" part has a bright and uniform finish. Able Electropolishing provided special handling, inspection and packaging for the part.
