#1031 - Salvaging Materials with Stainless Steel Electropolishing

Other - Manufacturer of fasteners

303 stainless steel

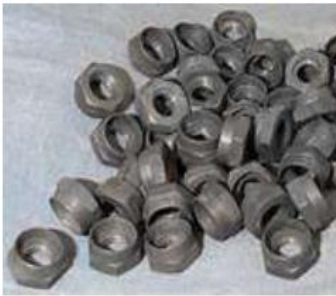
Before:

The client accidentally heat treated 30,000 "stop nuts" made of 303 stainless steel. As a result, the entire batch of parts was highly discolored and heavily oxidized. The client hoped to remove the heat treatment discoloration and oxidation in order to salvage the parts. Removing heat tint is not just a cosmetic improvement—this discolored oxidation can lead to future corrosion.

By electropolishing the stainless steel parts, we were able to clean and brighten them to a brilliant luster. The samples came out passivated and free of heat treatment discoloration, having been stripped of the oxidation that changed their color and would eventually cause corrosion. The client approved the electropolishing treatment, and Able Electropolishing processed 30,000 parts. By electropolishing the stainless steel back to its original shine, we prevented the client from losing several thousand dollars of material to scrap.
