Able Electropolishing Co., Inc.

#1075 Brite Microfinishing/ Endurance Finishing

Industry: Other - Manufactures of springs

Alloy: Rectangular Music Wire (Steel)

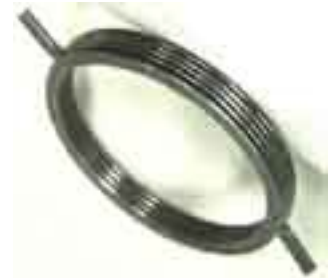
Problem: This part is used as part of a cylindrical lock assembly. The spring was failing prematurely due to fissures and cracks produced from the stresses involved in winding process. The part failed to meet cycle life requirements specified by the customer.

Solution: Electropolishing eliminated the stress points in the wire. After removing .0005 to .001 material, the parts exceeded the cycle life requirement. Raw springs reached 147,000 cycles. Electropolished springs reached 800,000 cycles. As surface metal was dissolved, so was the heat tint caused by the heat treat operation.
