## #1062 Brite Ultracleaning/ Brite Microfinishing

**Industry:** Other - Manufacturers of springs

**Mfg/Method:** Wire forming

**Alloy:** 1085 Music Wire

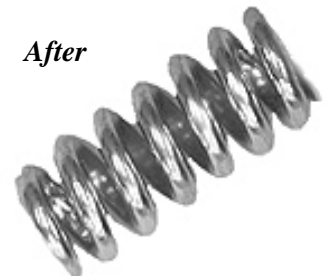
*Before*

*After*

**Problem:** The customer was experiencing problems with the part after plating and installing. The surface of the parts may not have been clean prior to plating, with resultant adhesion problems and flaking of plated material.

**Solution:** Electropolishing provided the customer with a cleaner part by removing the layer with imbedded contaminants from normal fabrication and lubrication. Electropolishing also smoothed out the surface of the wire providing a friendly “pre-plate” finish. Finally, electropolishing improved the cycle life of the part. Removing the outer layer counteracted the “notch effect” that occurs during the wire forming process.
